Recapping the Hammarlund SP-600

John Staples, W6BM

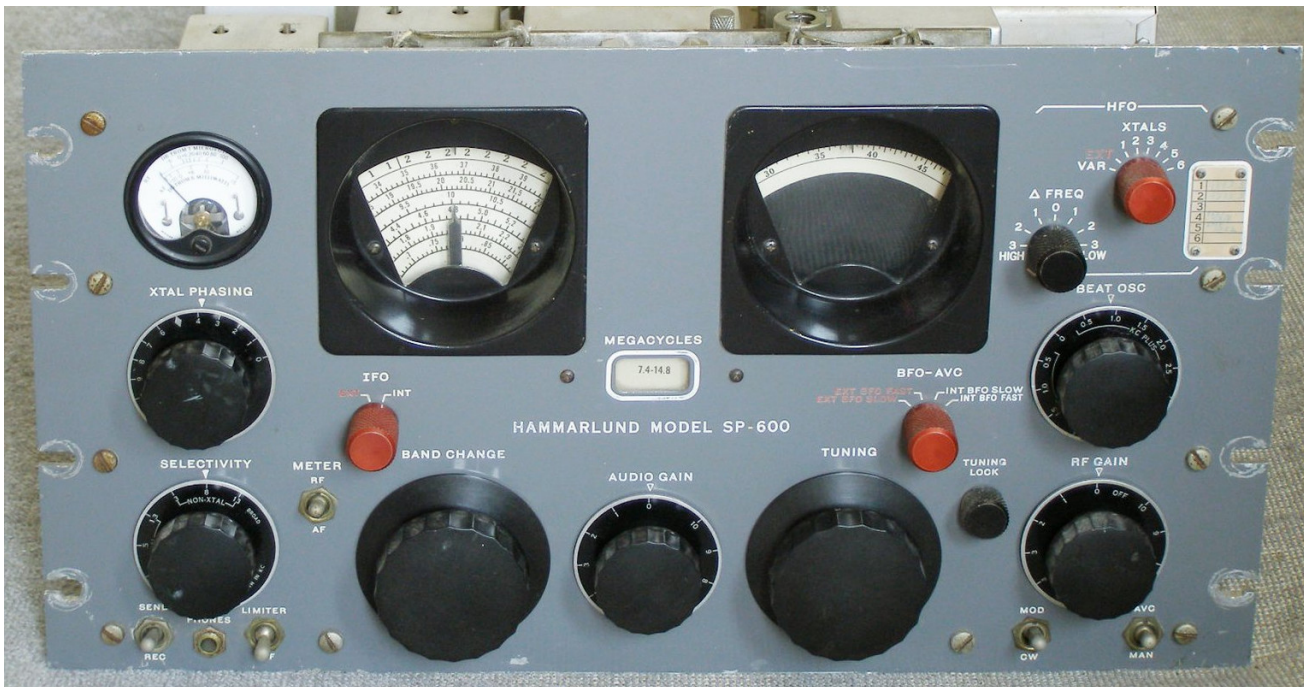
This is a dual-conversion receiver above 7 MHz, with the first IF at 3955 kHz, the second at 455 kHz. The JX-17 variant is easily recognized by its three red knobs, which allow the HFO, the first conversion oscillator at 3.5 MHz and the 455 kHz BFO to be substituted with external sources. For the ARRL Frequency Measurement Test contests, I derived these frequencies, and a fourth 456 kHz from an array of synthesizers locked to a GPS-disciplined frequency standard to get an accurate measurement.

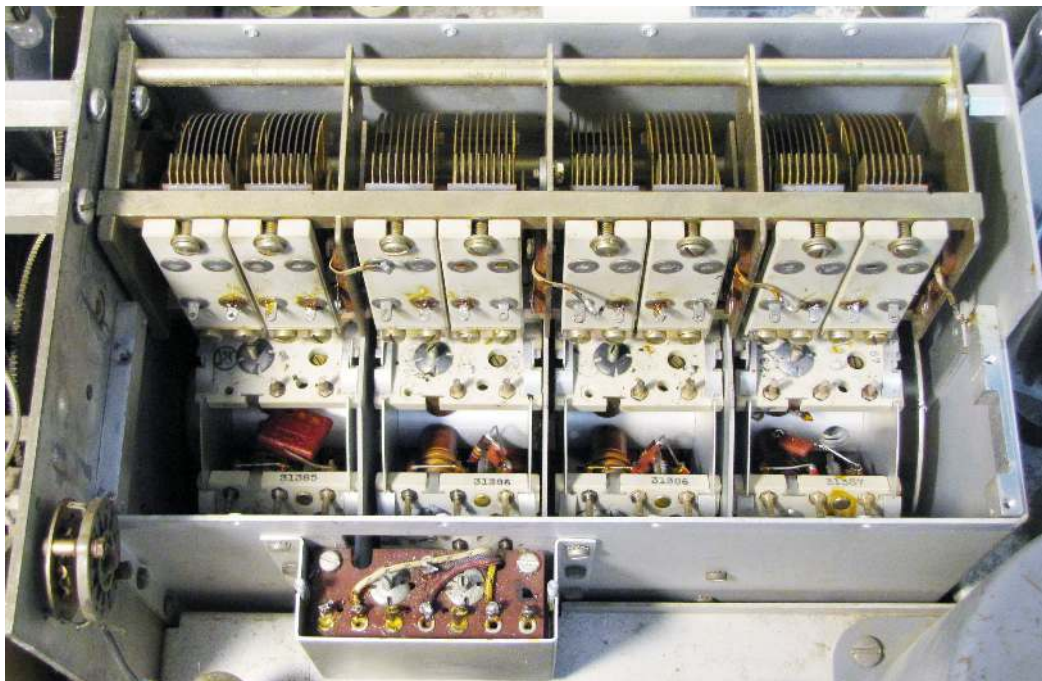
Here, the module containing the two RF stages, the mixer and oscillator has been removed from the RF deck, showing the top of the bandswitch turret. The multi-gang tuning capacitor is at the top, and the power supply tie points are in the small shielded compartment at the bottom.

The individual coil sections have contacts that engage with spring-loaded stationary contacts on the RF modules. It is a good idea to empty the coil assemblies for at least one frequency range from the turret so that the contacts would be protected from damage when the RF module is replaced.

The most challenging part of the upgrade is the replacement of the capacitors in the RF section, which must be detached from the chassis. This requires unsoldering all wiring connected from the circuit module to the tuning capacitor sections and also the power connections.

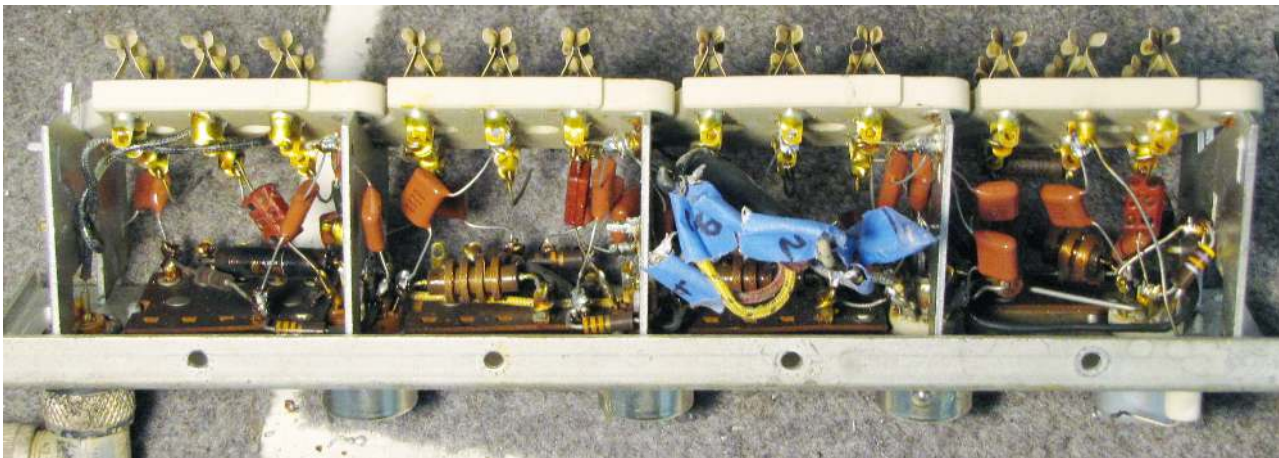
The IF cans contain BBs that must be replaced.

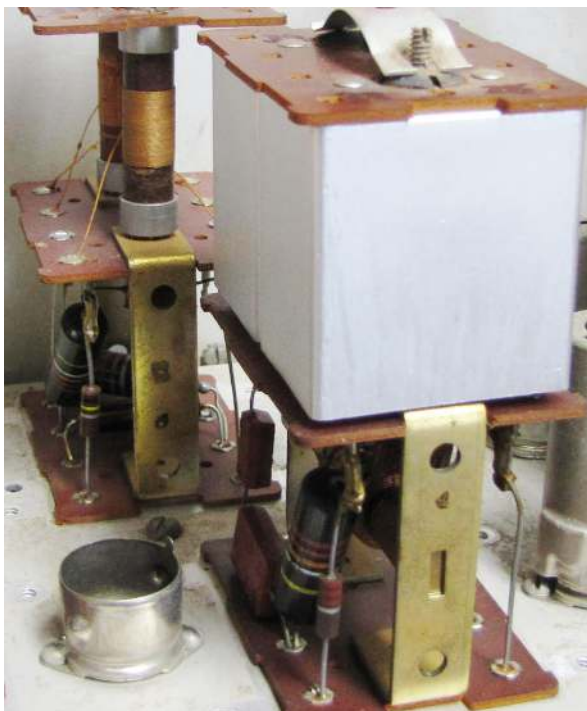
The ceramic-based RF modules for the lowest band(s) contain BBs.

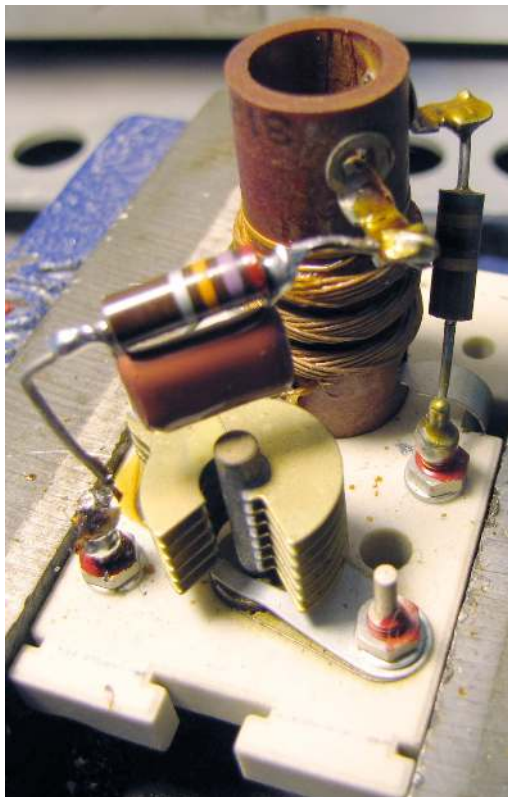
These individual coil modules are held onto the turret with small clips. Don't let these get loose and fly off!

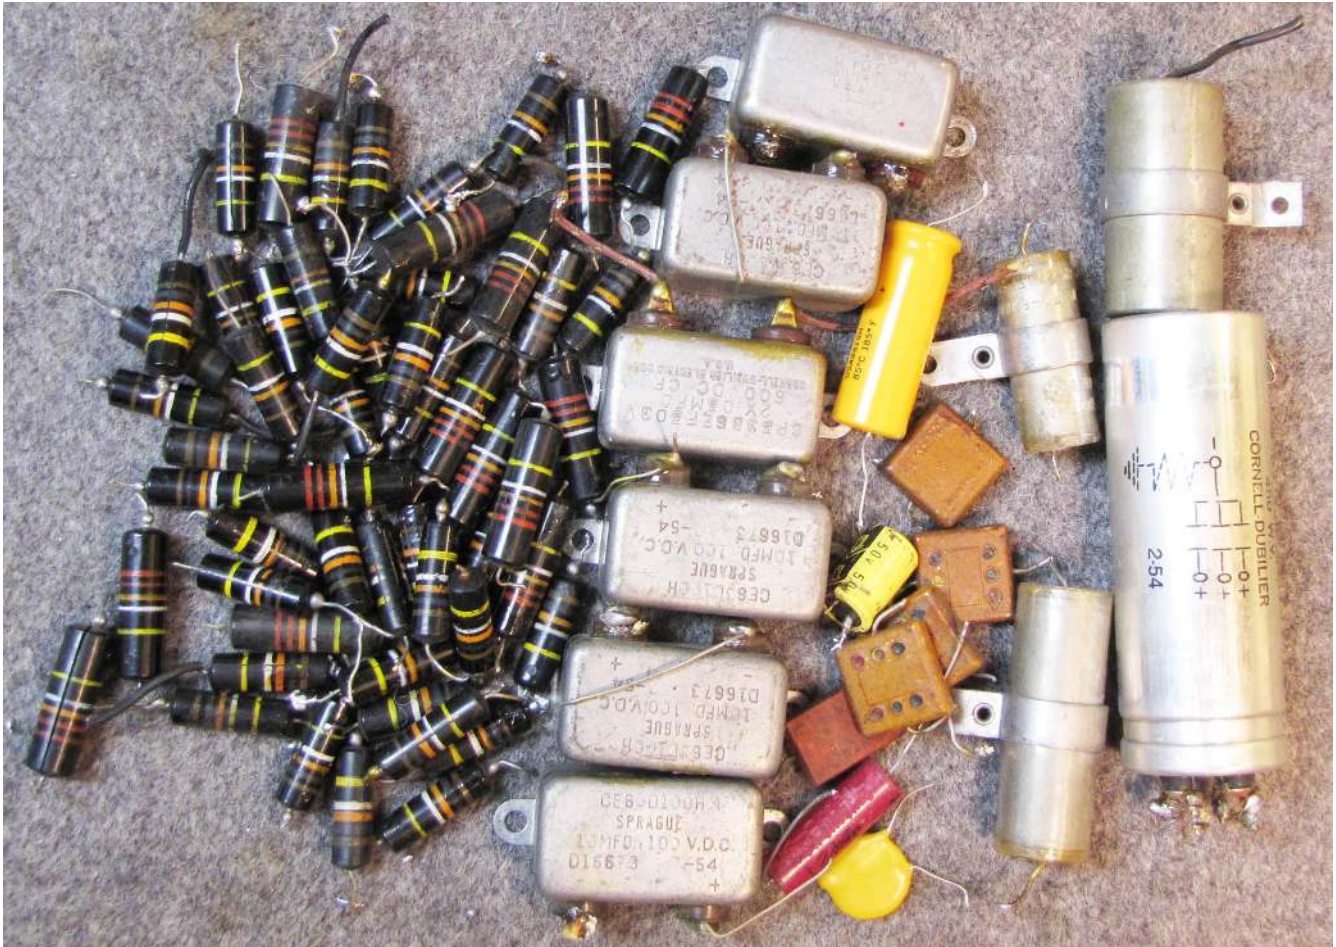
Here are all the capacitors removed, including a few from previous recapping.

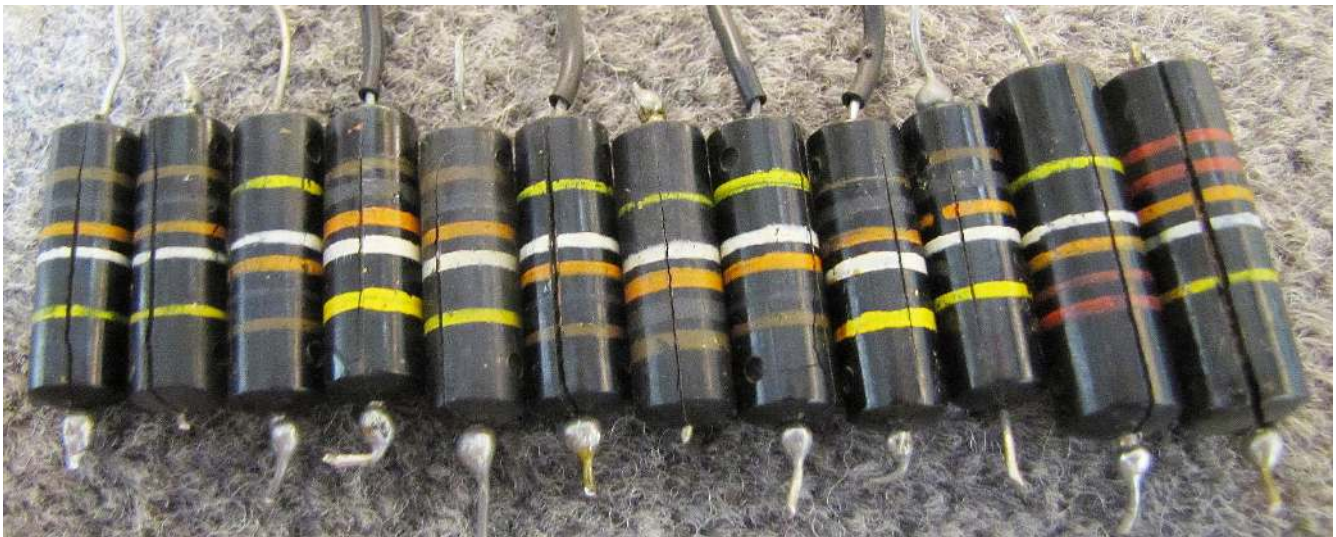
Many of the coupling and bypass capacitors in this receiver are the so-called “Black Beauties” (BBs) that over the last 60 years have seriously deteriorated by becoming electrically leaky with significant changes in capacitance.

Many of the BBs were split completely open along their axis.
