# Seth Arp Restores a Zenith H-845 AM-FM Tabletop

by Thomas Bonomo K6AD

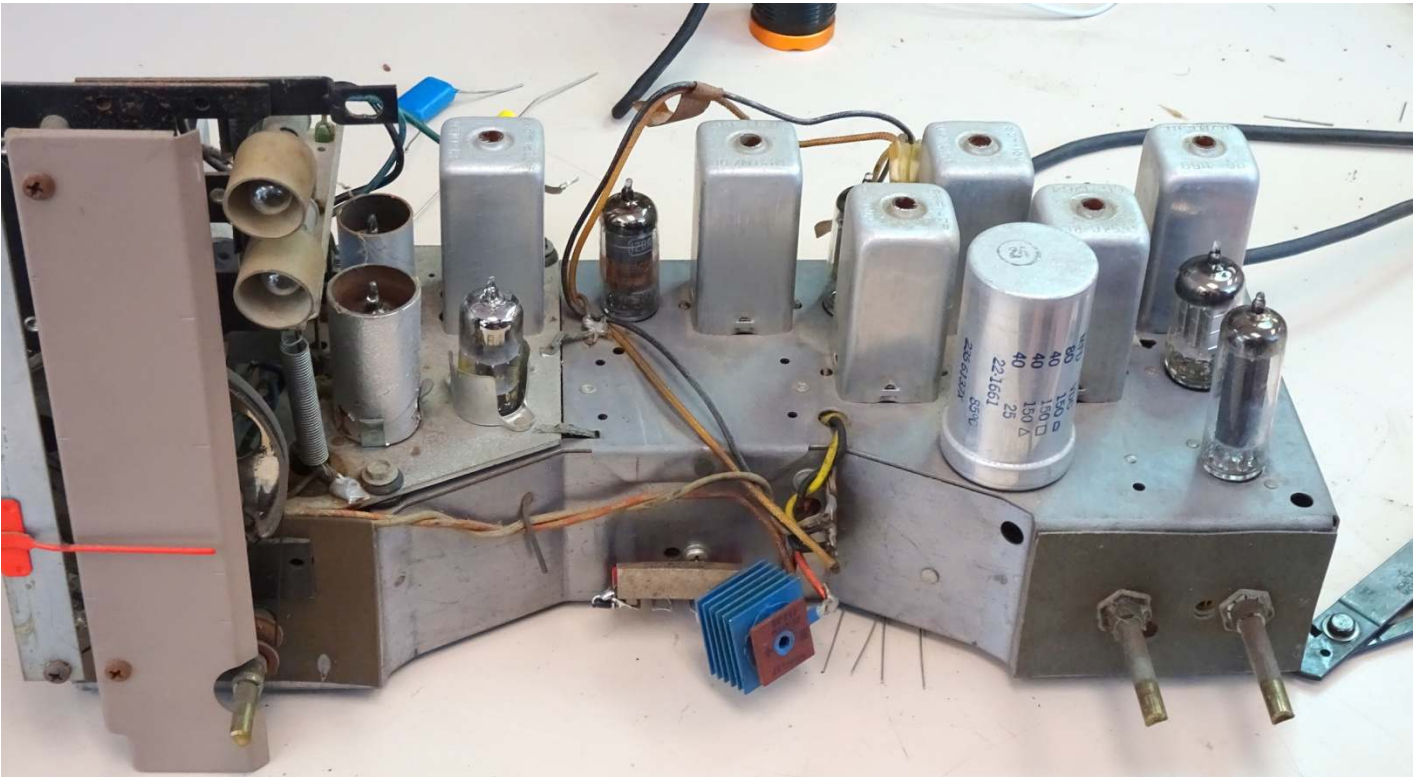
Replace the selenium rectifier (the blue finned device shown above) with a silicon diode such as a 1N4003, as the old selenium rectifiers are prone to failure. The smoke from these diodes is toxic. Silicon diodes have less internal resistance, so to prevent the B+ voltage from rising too high, insert a series resistance of about 100 ohms (10W) in series with the replacement diode. Make sure to fit the components close to the chassis so they don't interfere with the back of the speaker when you put the chassis back into the cabinet.

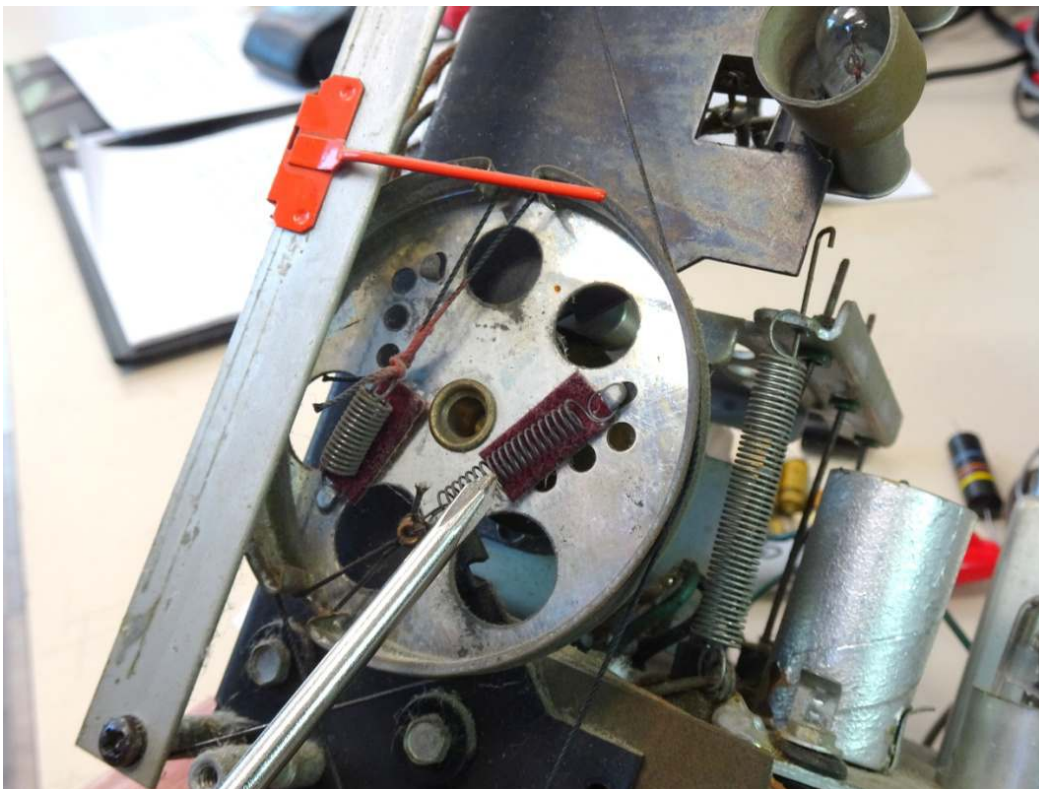
Before you begin recapping the radio, it is a good idea to take a photo of the dial string arrangement. If it breaks during the restoration process, you'll be glad you have photos. This might be a good time to see if the variable capacitor and dial pointer move smoothly when turning the knob. If there is slippage, tighten the tension by lifting the end of the

the spring from main pulley and reattaching it further up the coil spring (see photo at right). Decades ago, some restorers used cloth line to replace broken dial string cords, and these usually deteriorate with time and break. Make sure to use nylon line for long life.

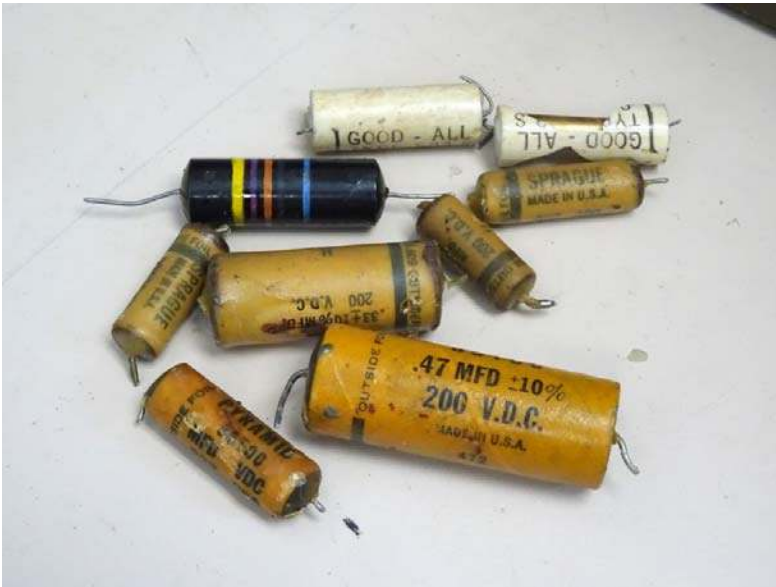
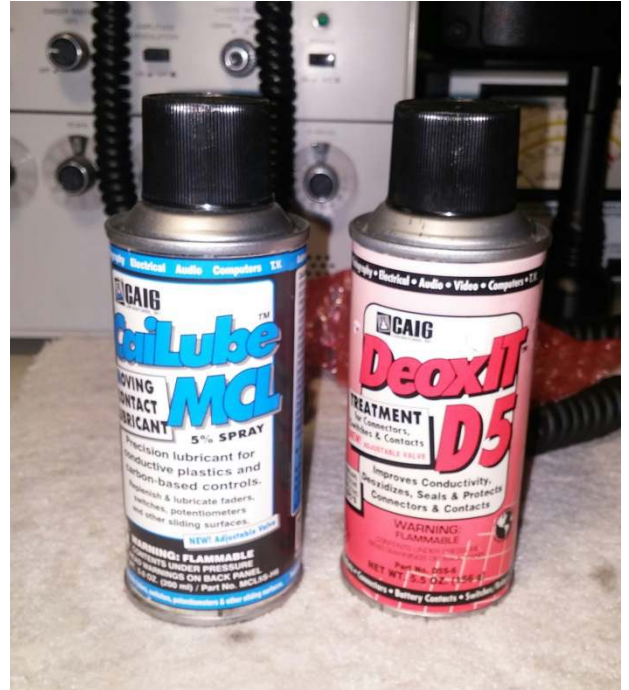
The paper capacitors are easy to identify, and fortunately there are only a handful in this chassis. Notice that the “black beauty” capacitor is color coded like a resistor, but should not be confused with one. The value of the black beauty shown here is .047uF.

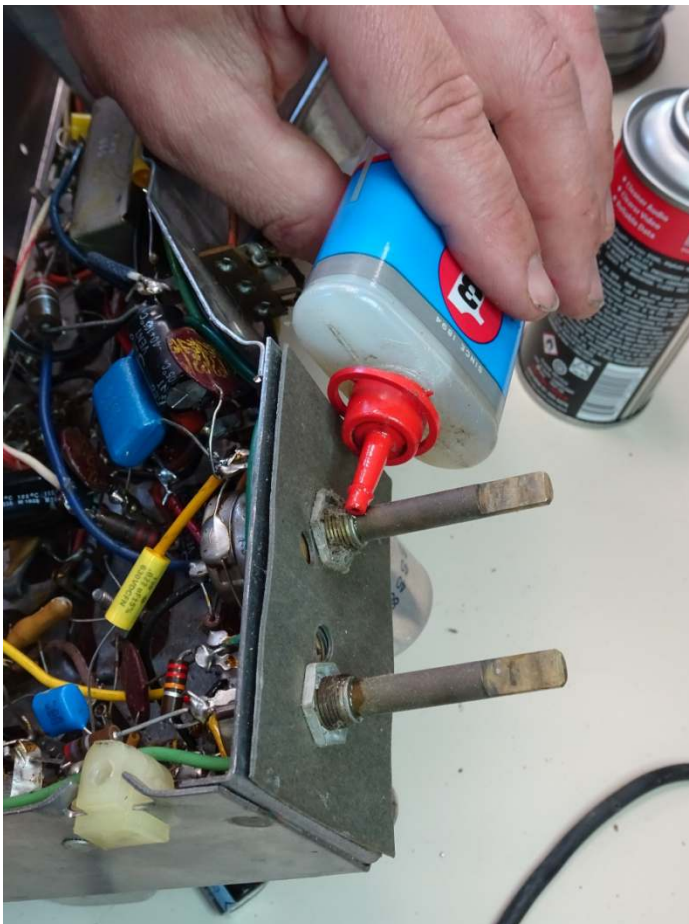
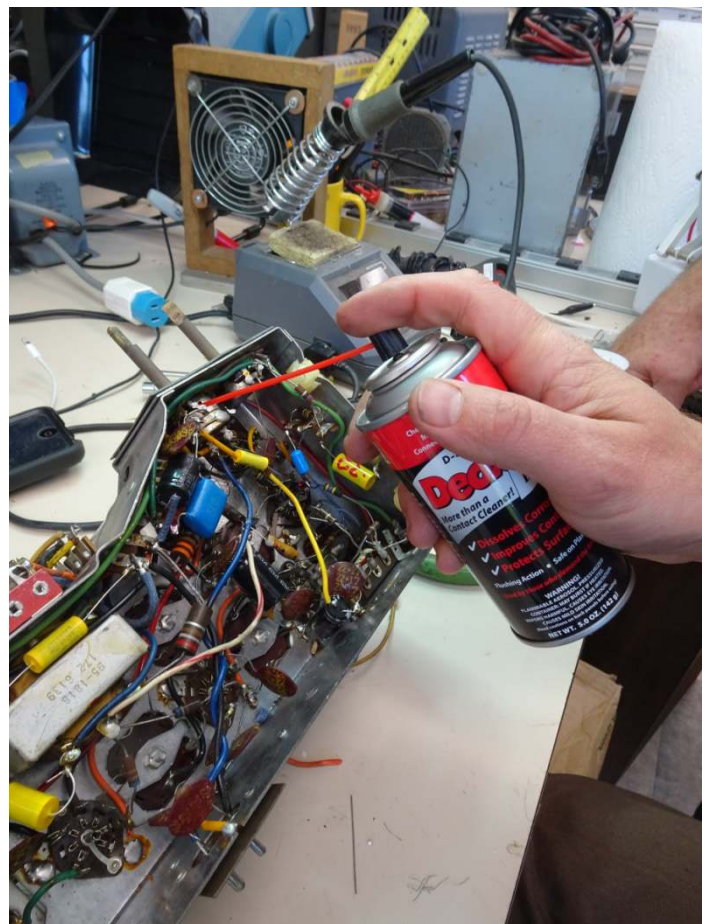
Once you’ve finished recapping, give the radio a test. If everything works and you don’t have any troubleshooting to do, give the controls a shot of moving contact lubricant such as Calilube MCL. Use DeoxIT D5 on switches. A very small amount of oil on some of the shafts will also help.
