Hints & Kinks:  
Twenty Years of the

# California Historical Radio Society

For the Restoration and Preservation of Early Radio

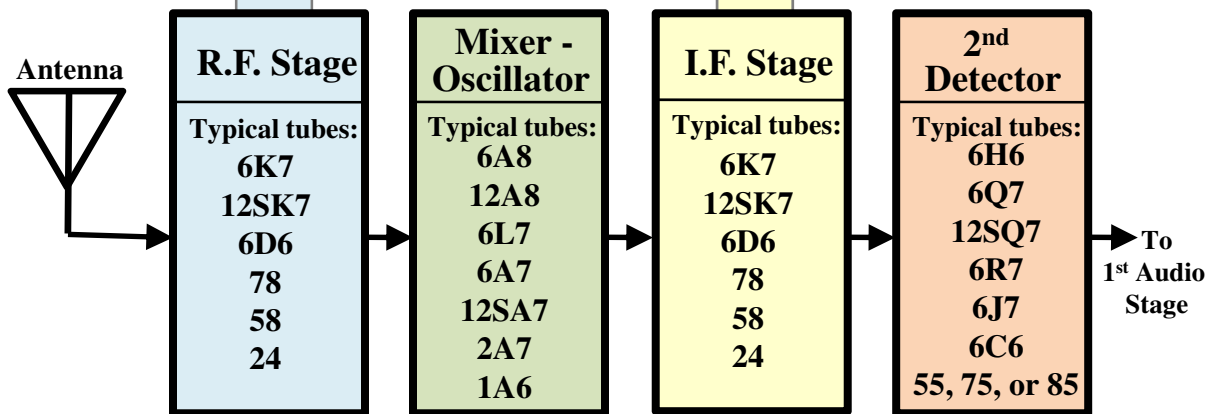
SYMPTOMS	Mixer - Oscillator Stage	2nd Detector
<b>Inoperative</b>	<ul style="list-style-type: none"> <li>• Oscillator plate resistor open</li> <li>• First I.F. transformer primary open</li> <li>• Shorting or open osc. trimmer condenser</li> <li>• Open plate choke coil</li> </ul>	<ul style="list-style-type: none"> <li>• Plate load resistor open or shorted</li> <li>• Shorted trimmer condenser</li> <li>• Control grid lead shorting to shield</li> <li>• Open plate filter choke</li> </ul>
<b>Intermittent Fading</b>	<ul style="list-style-type: none"> <li>• Poor insulation on osc. trimmer condenser</li> <li>• Open grid return resistor</li> <li>• High resistance at lugs of oscillator coil</li> <li>• Open plate choke cell</li> </ul>	<ul style="list-style-type: none"> <li>• Defective volume control</li> <li>• Load resistor bypass condenser shorting</li> <li>• High resistance contact in I.F. transfmr sec.</li> <li>• RF bypass condenser shorting</li> </ul>

<b>Oscillation or Noisy</b>	<ul style="list-style-type: none"> <li>• Open grid coil</li> <li>• Cathode bypass condenser open or leaky</li> <li>• Shield on grid leads corroded or open</li> <li>• Decoupling resistor shorted</li> </ul>	<ul style="list-style-type: none"> <li>• Open plate or grid bypass condenser</li> <li>• Defective volume control</li> <li>• Out of alignment</li> <li>• Defective plate load resistor</li> </ul>
<b>Distortion or Hum</b>	<ul style="list-style-type: none"> <li>• Leaky plate bypass condenser</li> <li>• Shorted or leaky cathode bypass condenser</li> <li>• Open grid filter condenser</li> <li>• Oscillator coil misaligned</li> </ul>	<ul style="list-style-type: none"> <li>• Defective volume control</li> <li>• Leaky audio coupling resistor</li> <li>• Plate load resistor too high</li> <li>• Leaky plate bypass condenser</li> </ul>

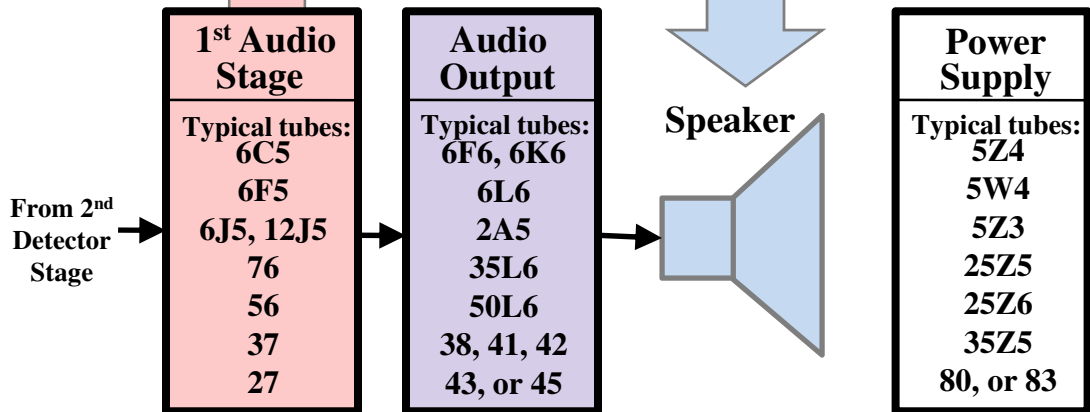
SYMPTOMS	1 <sup>st</sup> Audio Stage	Speaker
<b>Inoperative</b>	<ul style="list-style-type: none"> <li>• Plate load resistor open</li> <li>• Open audio coupling condenser</li> <li>• Shorted plate bypass condenser</li> <li>• Open cathode resistor</li> </ul>	<ul style="list-style-type: none"> <li>• Open voice coil</li> <li>• Open output transformer secondary</li> <li>• Open voice coil leads</li> <li>• Voice coil leads shorted to pole piece</li> </ul>
<b>Intermittent Fading</b>	<ul style="list-style-type: none"> <li>• Defective audio transformer primary</li> <li>• Open volume control</li> <li>• Leaky grid or plate coupling condenser</li> <li>• Defective plate load resistor</li> </ul>	<ul style="list-style-type: none"> <li>• Voice coil lugs making poor contact</li> <li>• Metal filings grounding voice coil</li> <li>• Output transformer secondary opening</li> <li>• Field coil connections making poor contact</li> </ul>

<b>Oscillation or Noisy</b>	<ul style="list-style-type: none"> <li>• Shorted cathode bypass condenser</li> <li>• Shorted plate decoupling resistor</li> <li>• Open plate bypass condenser</li> <li>• Interstage transformer primary opening</li> </ul>	<ul style="list-style-type: none"> <li>• Metal filings grounding voice coil</li> <li>• Warped cone</li> <li>• Voice coil rubbing on pole piece</li> <li>• Voice coil winding loose</li> </ul>
<b>Distortion or Hum</b>	<ul style="list-style-type: none"> <li>• Shorted grid or plate coupling condenser</li> <li>• Shorted cathode bypass condenser</li> <li>• Audio transformer open or shorted</li> <li>• High resistance between primary and secondary of audio transformer</li> </ul>	<ul style="list-style-type: none"> <li>• Field coil open or shorted</li> <li>• Hum bucking coil shorted or reversed</li> <li>• Voice coil rubbing on pole piece</li> <li>• Unfiltered field power supply</li> </ul>

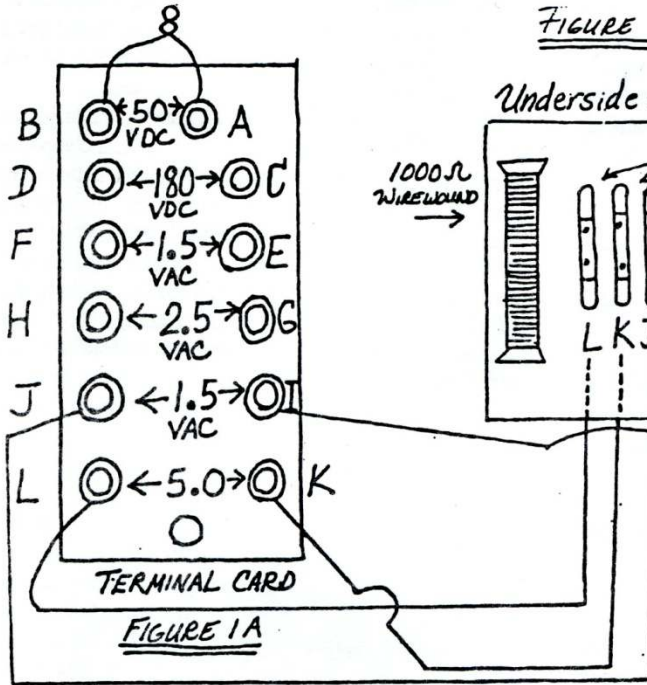
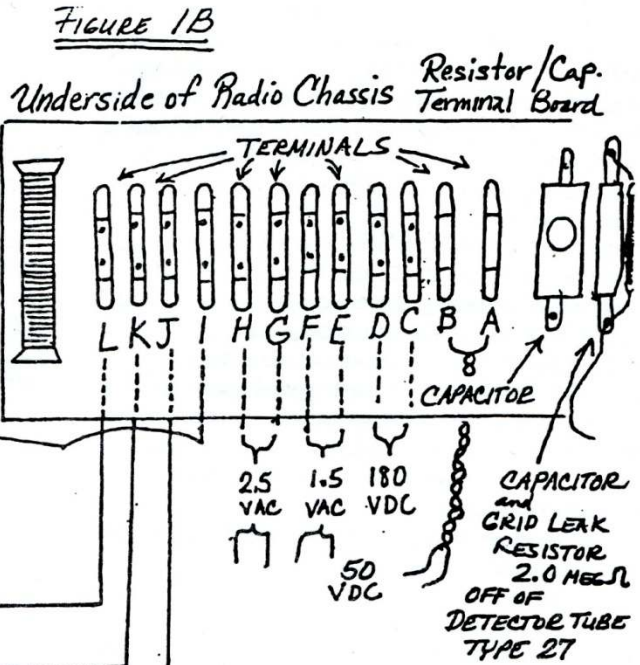
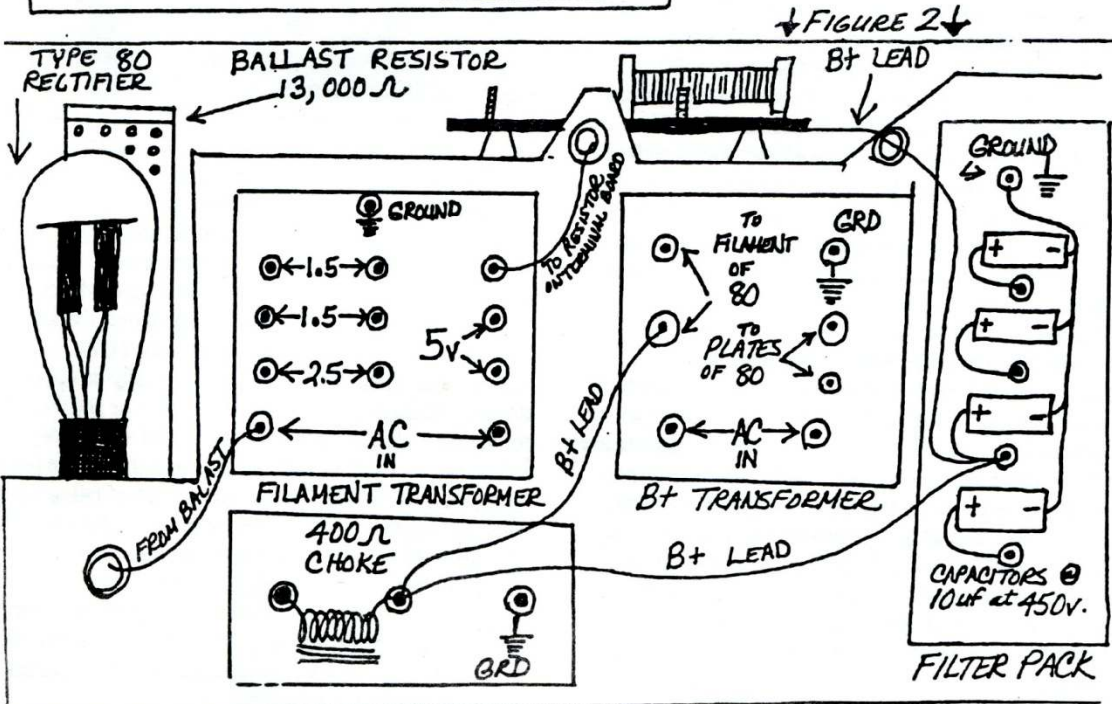
If you've powered up your set and there is no sound, everything appears normal, you probably have an open wire-wound resistor, located on the top of the power supply. There are three of them and they are notorious for failing. The one I replaced in my set is 1000 ohms. There are also a 2300 ohm and a 15,000 ohm resistor. If your set happens to be a later version, there will be a fourth resistor with the value of 1000 ohms. These can be replaced with 25 watt wire-wound units. If this fails to bring sound to your set, and your voltages seem normal (check them against figure 1A on the terminal card), then you may have an open audio transformer.

If the set operates, but seriously distorts, check the grid-leak resistor off the detector tube (type 27), located on the radio chassis resistor/terminal board in figure 1B, on the extreme right. It may have changed significantly in value or opened up completely, thus not creating enough bias for the 71-A output tubes. A 2.0 meg ohm resistor should cure this ailment. Fortunately I was able to get my Majestic model 71-B to operate will without any complications. So far I've enjoyed playing the set tremendously. It has ample power and good tone for this

transformer; the B+ transformer: the filter choke; and the filter capacitor pack. All units can be removed individually, if necessary. Replace each lead with a new wire, and remove them individually to avoid confusion with the wiring (see figure 2 for layout of the terminals on the power supply). It will be necessary to remove the terminal strip on the top of the power supply to remove have access to the wiring underneath.

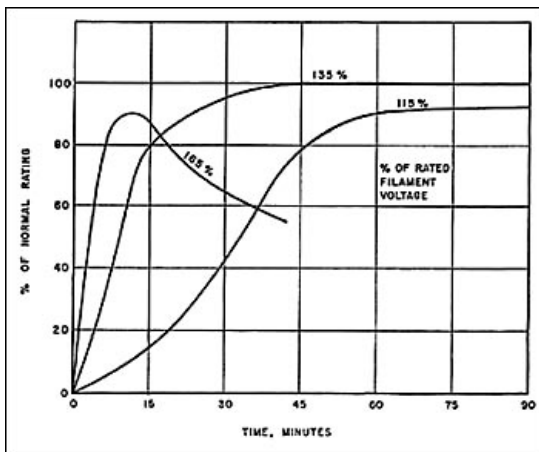
Summary of data accumulated by author on rejuvenation of thoriated tungsten filaments. Best results are obtained at 135% of rated filament voltage. At 115%, rejuvenation time is very significantly increased; at 105%, the tube is quickly destroyed.

applied to a thoriated tungsten filament during rejuvenation. It shows that a voltage lower than the recommended value will eventually result in a fairly good tube, while too high a voltage will result in a tube which remains weak

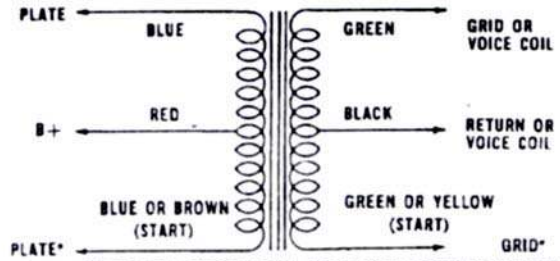
## AUDIO & OUTPUT TRANSFORMERS

\*FOUND ONLY ON PUSH-PULL PRIMARY OR SECONDARY WINDINGS

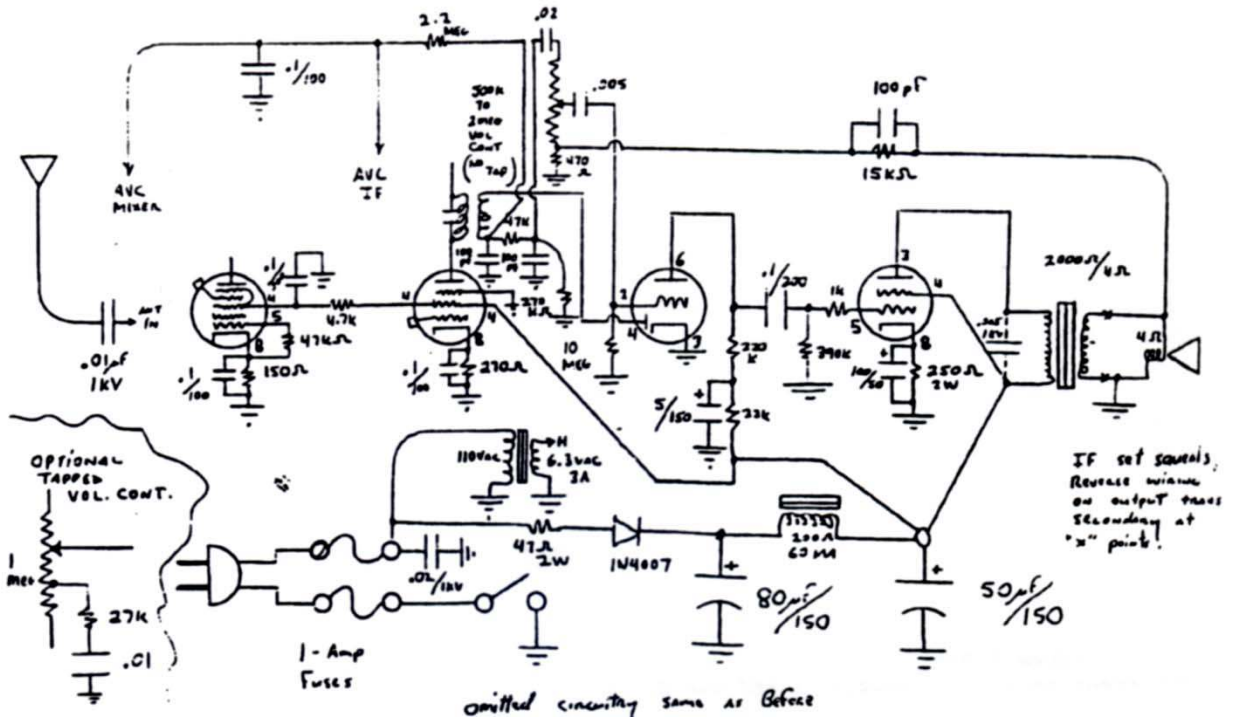
# Illustrations for: IMPROVE THE PERFORMANCE OF YOUR AC/DC SETS

6A8

6K7

6S07

6Y6 GT/C

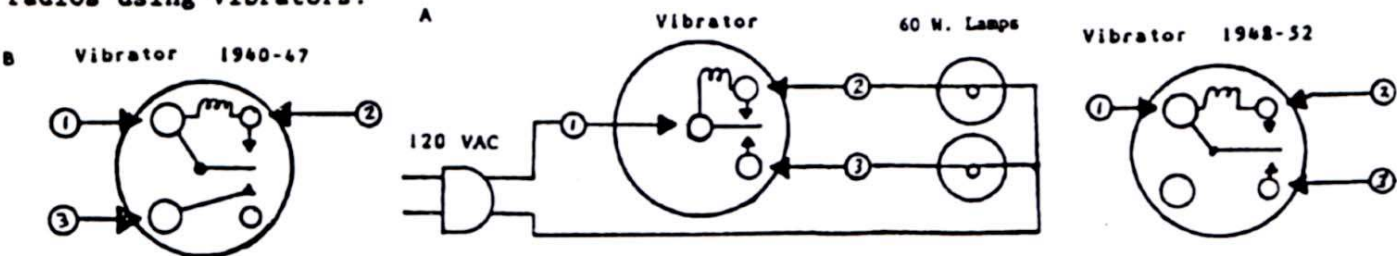
**Diagram A shows the connections to a 12 V. 3 prong vibrator used in 1953 and later radios using vibrators.**

**Diagram B applies to 6 V. 4 pin vibrators used from 1940 thru 1952. Note the two different internal connections and two different pin diameters.**

Diagram A shows the connections to a twelve volt, three prong vibrator used in 1953 and later radios rising vibrators. Diagram B applies to six volt, four pin vibrators used from 1940 through 1952. Note the two different internal connections and two different pin diameters. Cadillac used several types of synchronous vibrators prior to 1940. The contact arrangements are too varied to cover in this article. These vibrators use a second set of contacts instead of a rectifier tube to produce the plate supply voltage. The second set of contacts must also be free of oxide to produce the proper plate voltage. The same testing principles apply to these vibrators. One lamp is used to find the contact associated with the coil and make the vibrator vibrate. The second lamp is used to "clear" each of the remaining contacts in turn. Mark the installed position of the vibrator before removal from the radio as some of these vibrators can be rotated 180 degrees, which will result in the wrong polarity of plate supply voltage and non-operating of the radio.

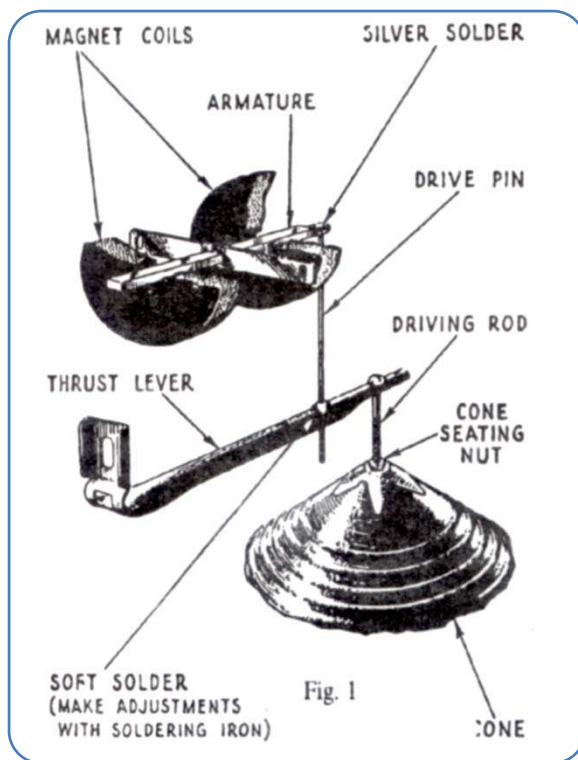
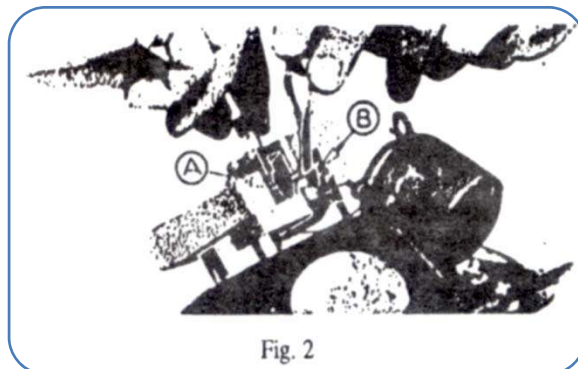
Two of these tools are necessary when adjusting the armature. Place one tool in the space between the armature and pole piece of the motor mechanism at the end next to the filter unit (Fig 2).

The other tool is placed at the other end of the armature a little to one side in order to clear the drive pin located at this end of the armature. By loosening screw A and B (Fig. 2) any tension in either direction which may have been on the armature is released and the spacer tools will provide the correct clearance or spacing. While the spacer tools are in place a hot soldering iron is applied to the drive pin thrust lever, connection point C (Fig. 1), and the solder heated sufficiently to allow the drive pin to find its normal position with regard to the thrust lever. The iron is now removed. Screws A and B (Fig. 2) are tightened and the spacer tools removed. The armature is now correctly aligned and balanced so that no abnormal strain is being imposed upon it in any direction.

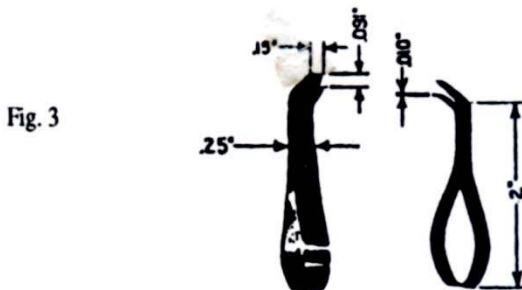
Shim tools for adjusting speaker armature

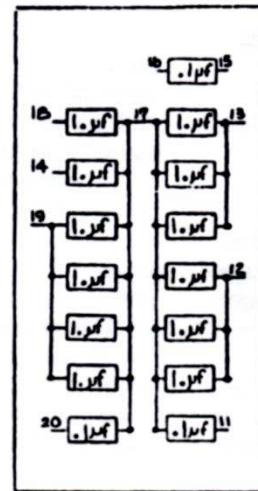
CONDENSER BANK (INTERNAL)

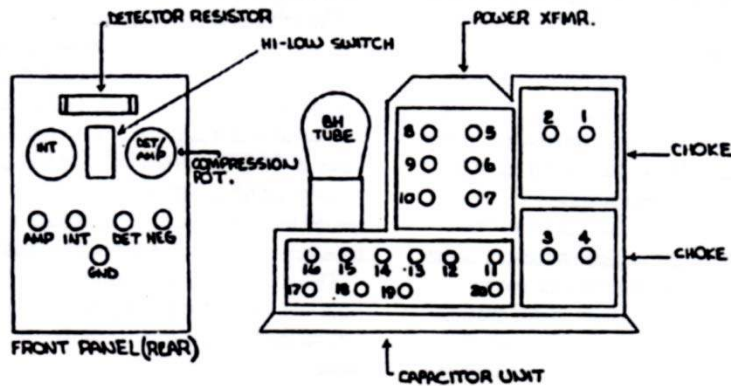
ELIMINATOR COMPONENT LAYOUT

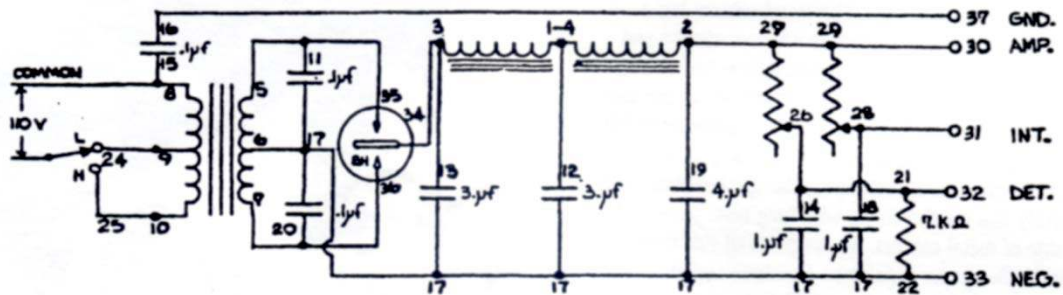
MAJESTIC STANDARD, SUPER, B ELIMINATOR

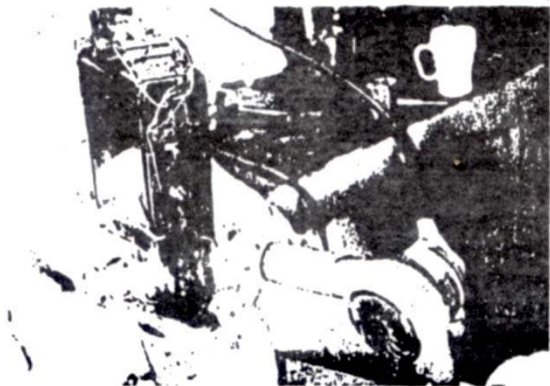
Melting out the tar with a heat gun

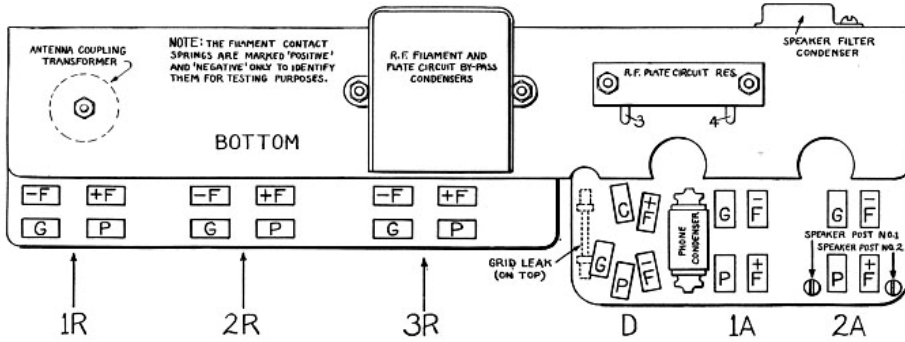
FIG. 90. CHART FOR MODEL 40, 40-F, 42, 42-F, 52, 56 AND 57.

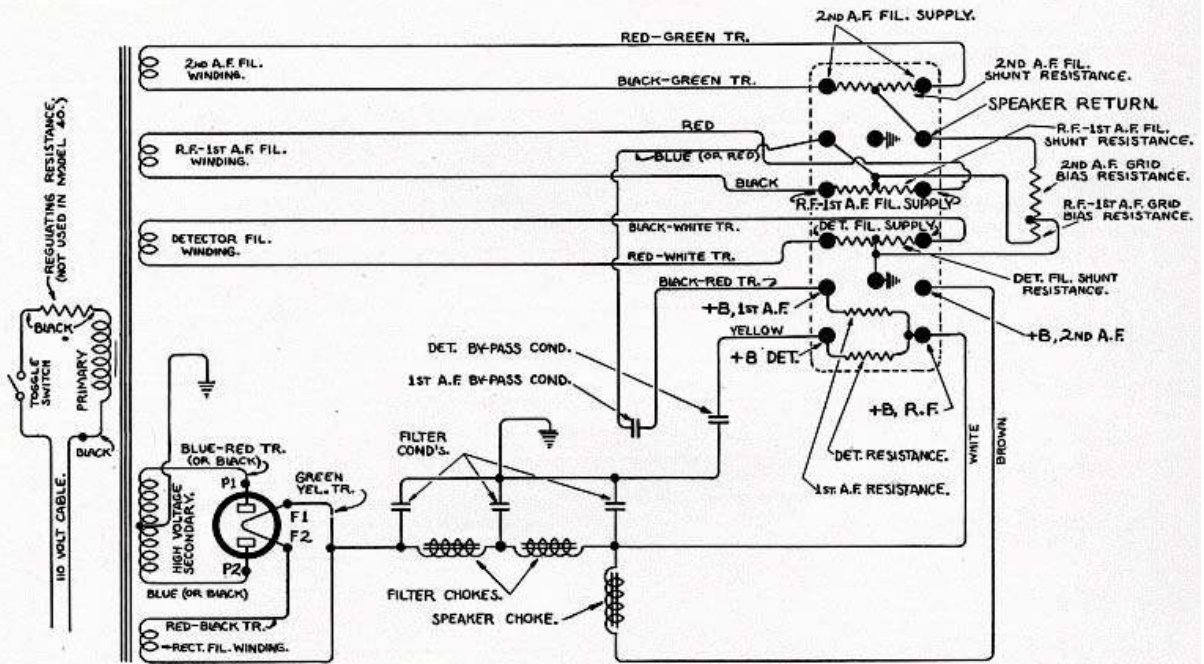
FIG. 63-A. SCHEMATIC DIAGRAM OF POWER UNIT IN MODELS 40, 42, 44, AND 52. SEE PAGE 69 FOR DESCRIPTION OF THIS UNIT. SOME EARLY UNITS HAVE COLOR SCHEME SIMILAR TO UNIT IN MODEL 38 SET. NOTE THAT COLORS AS NOW STANDARDIZED CORRESPOND WITH THE COLORS OF SET-CABLE LEADS.

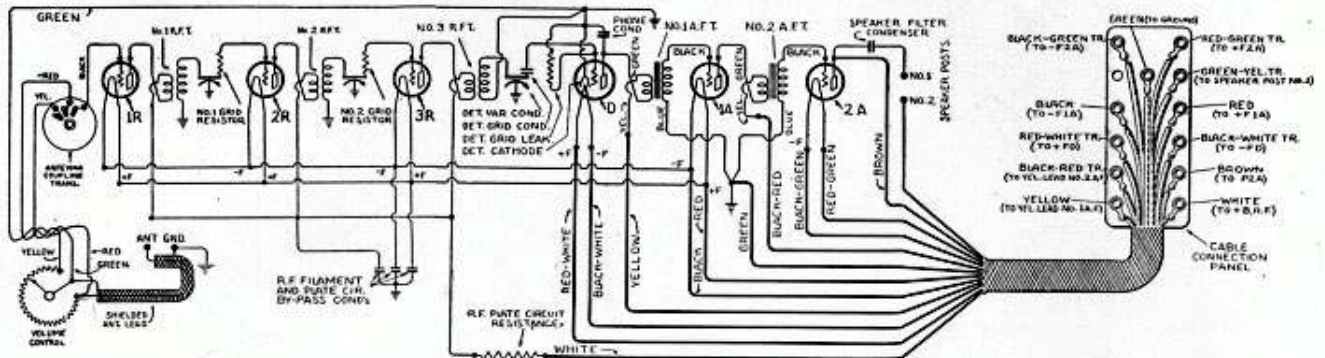
FIG. 87. WIRING DIAGRAM OF MODEL 40, 40-F, 42, 42-F, 52, 56 AND 57.

Model 52 does not have the shielded antenna lead, but is provided with two twenty-foot leads which are connected to the volume control, black for antenna and black-green tracer for ground. Model 56 and 57 have antenna and ground posts at the bottom of the cabinet.
