CHRS

JOURNAL

VOL 7

JAN-DEC 1982

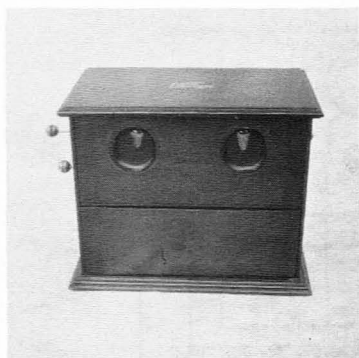
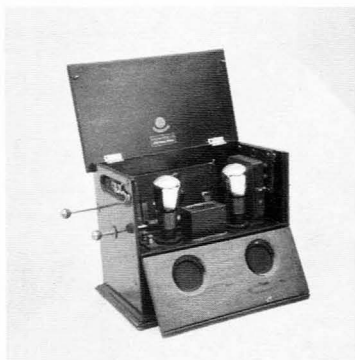
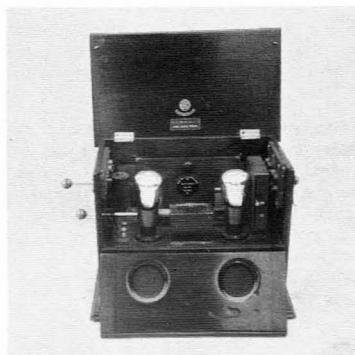
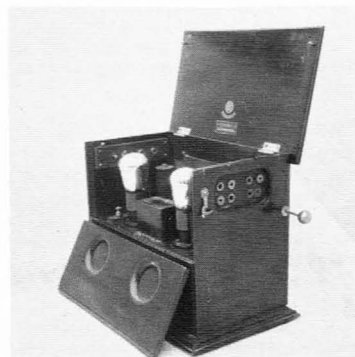
Marconiphone V2 Reflex Receiver

The photographs of the V2A were supplied by our Bill Baker, W7IYY. You will recall that this set, which is a gem, won first place in the reflex category at our A.W.A./C.H.R.S. 1981 Meet. Bill's set is truly in mint condition and we thank him for contributing these photographs.

In addition to the so-called spade tuning, the set is also unique in that no controls appear on the front panel other than the regeneration control which consists of a vertical lever attached to a plug-in regeneration unit. The aforementioned tuning spades are moved across the flat coil by means of rods which extend outside the cabinet left and right sides, and which have knob handles. An additional knob, located on the left side of the cabinet, is attached to a resistor which controls the filament voltage. Later models used a differential screw to move the spades rather than the original push-pull arrangement. The flat coils are referred to as range blocks and are of the plug-in variety. Eleven blocks were available to cover the range from 185m to 3200m. In addition, six different regeneration plug-in units were available to cover the various ranges. Usually, two range blocks were furnished with the set to cover 300m to 530m with one applicable regeneration unit. Normally, the V2 (V2A) used D.E.R. tubes having 1.8 filament voltage and 30-50 volts on the plates.
