Canadian Vintage Radios

The Publication of the
Canadian Vintage Radio Society
Incorporating the CVRS Newsletter

Spring 2023 Issue

A 'Brace' of Scott Allwave's... and Some Radio TLC - Part 4— Kevin Christopher and Gerry O'Hara

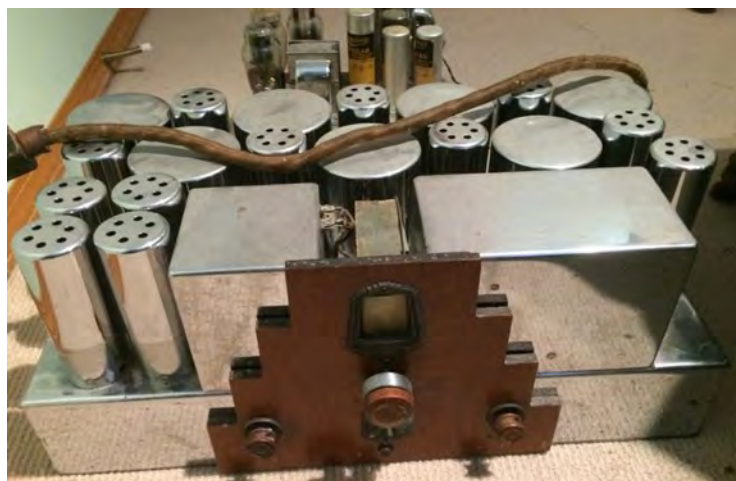
I (Gerry) was contacted in late-Summer/Fall of 2021 by someone asking if I was willing to 'check out' two E.H. Scott radios he owned: a Scott 'Allwave 15' (AW15) chassis – photo, right, and a 'Scott Sixteen' (photo on Page 2). Subsequent email correspondence and phone calls enlightened me to the fact that the owner of these radios was actually E.H. Scott's nephew. He had bought the AW15 set

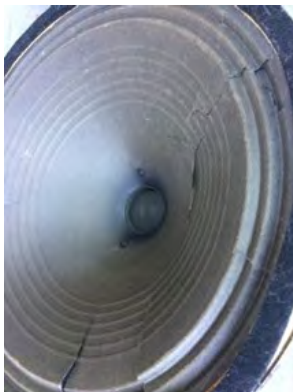
The speaker cone had been damaged (photo, left), and the owner arranged to have the speaker re-coned in Vancouver – a process that took five months. The upshot was that the speaker, with its cone repaired, and the AW15 chassis, arrived at my house around the same time, over six months after the first enquiry, ie. in May 2022.

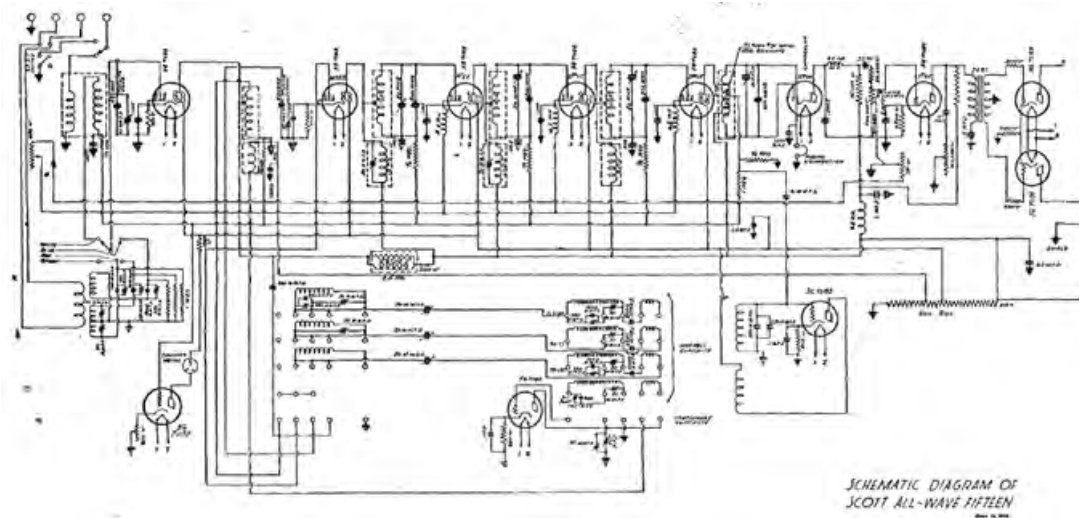
- '4/10/34' dated diagram [below] uses the Wunderlich tube 2nd detector. The 2 grids are not strapped together, #58 mixer, 4 antenna posts;
- '5/7/34' dated diagram uses the Wunderlich tube 2nd detector. The 2 grids are not strapped together, #58 mixer, 4 antenna posts; and
- an undated [diagram], believed to be early-Fall 1934, using a #55 tube, 2 diodes... wired to the separate ends of the last IF secondary for push-pull detection, 2A7 mixer, 2 antenna posts.

In those 3 early diagrams, the last IF transformer secondary is center-tapped. However, that first non-Wunderlich diagram shows the #55 tube is wired for full wave detection from the 4th IF tapped secondary, not half wave [like the chassis on my workbench]. Your #55 tube wired for half wave detection, like the last two dated diagrams, is not con-

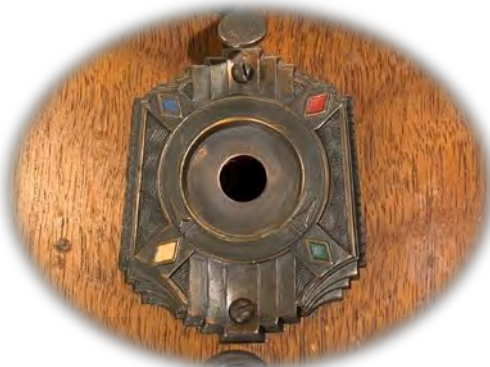
Perhaps the most striking feature of the circuit implementation is the use of a turret to change the RF coils (photo, left). The mixer and local oscillator coils and their associated trimmer capacitors are mounted on a carousel with contacts that connect with two sets of multiple fixed contacts and a single fixed contact mounted on the underside of the chassis. Such an arrangement greatly sim-

plifies the band switch wiring, and its rigidity results in enhanced stability and is less prone to unwanted (spurious) oscillations, especially at higher frequencies. All coils and transformers are very well made and much larger in form than found in most other radios, and those not mounted on the carousel are all well-screened. The associated trimmer capacitors are also of high quality.

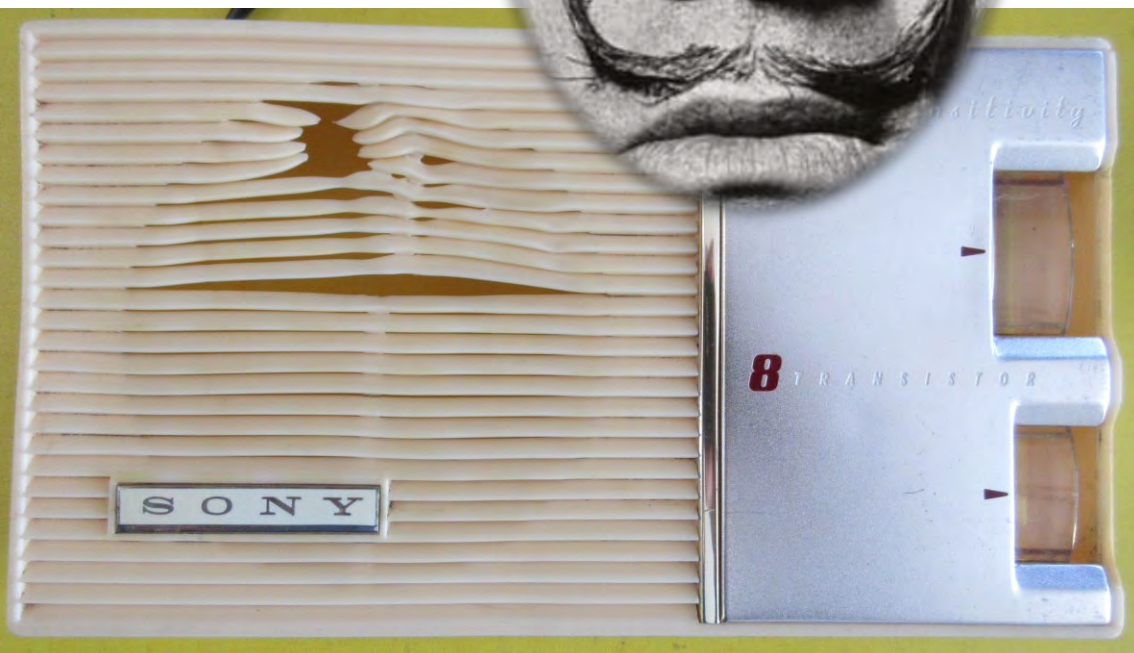
But I completely forgot about the plastic case that was drying out on the electric baseboard...

When I picked it up, it was melting away, like that clock painted by Salvador Dali (below). So now I have a 'Transistor Dali!' - photo, left.

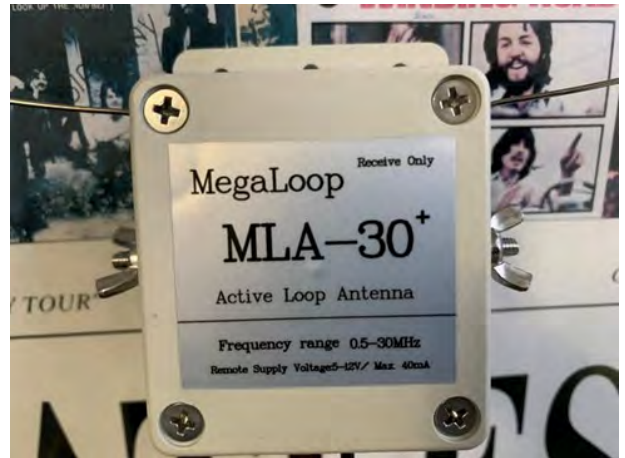
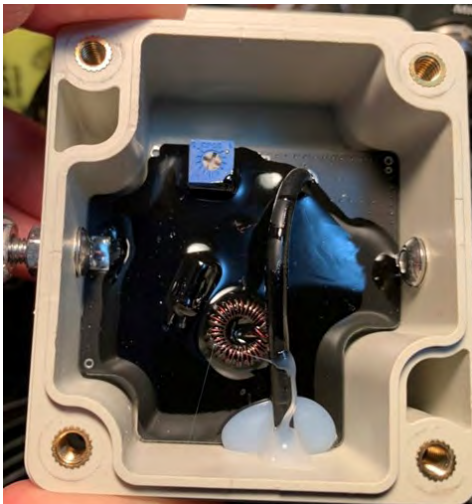
The unit I bought was an 'MLA-30+' – available on Amazon and eBay, and comprises a stainless steel loop, a waterproof amplifier box to which the loop connects directly, the output of which feeds around 10m of thin coax to a 'bias-T' box (photo, below), that provides power to the amplifier box and splits out the amplified signal to be sent to the receiver. A bit over-priced for what it is, but if it works, I thought, 'bite the bullet' and give it a try for Christmas!

Well, so far, I have been pleasantly surprised – I tried it out on my Ed-dystone 940 and Radio Shack DX-394 receivers, and it definitely improved reception on the Broadcast band on both, with several weaker stations that are normally battling against the cacophony of interference in my workshop clearly audible and at improved strength, especially when the loop is oriented for optimal reception (like all loops, it is directional). It also works reasonably well on the shortwaves, with WWV and several broadcast stations being received well.

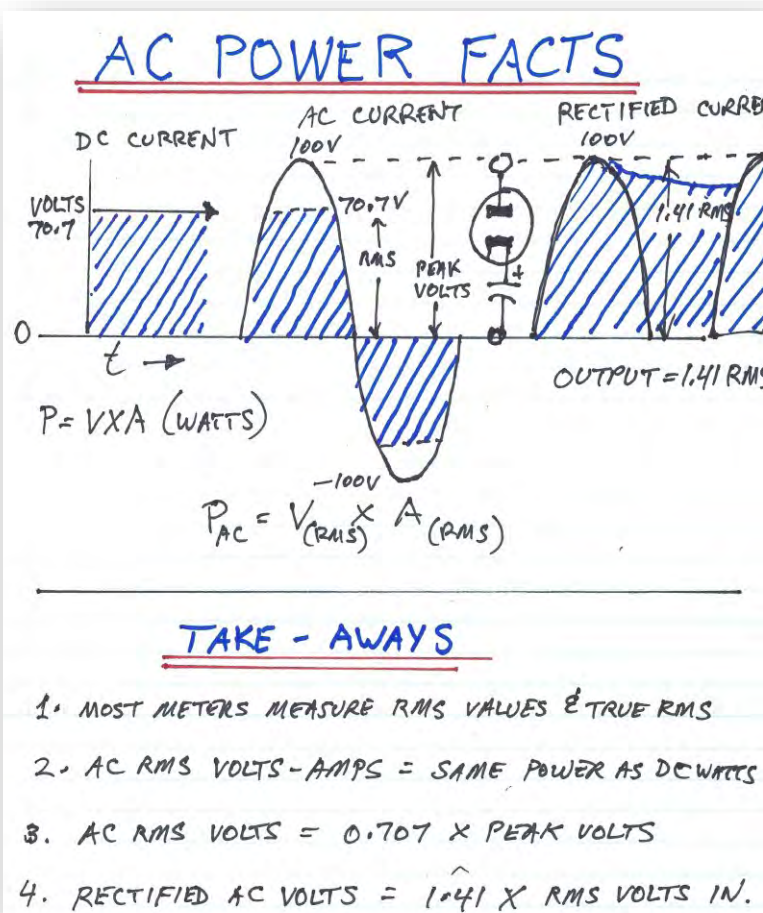
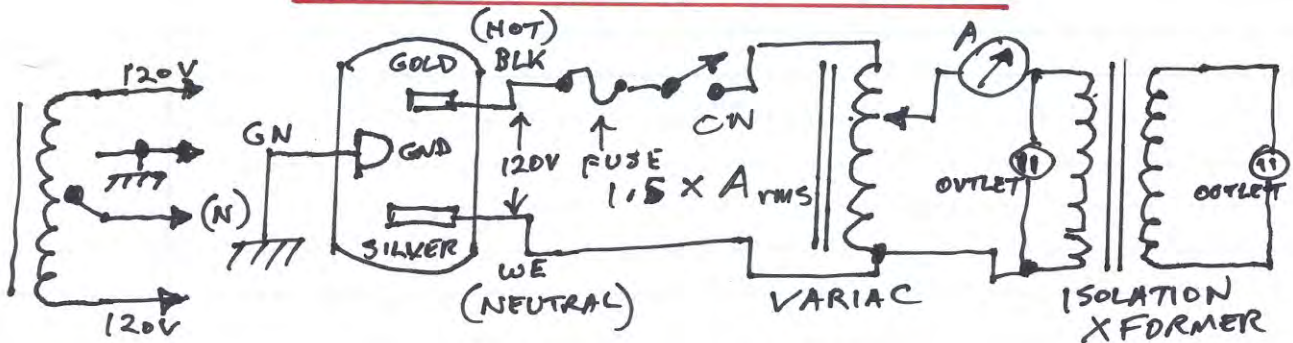
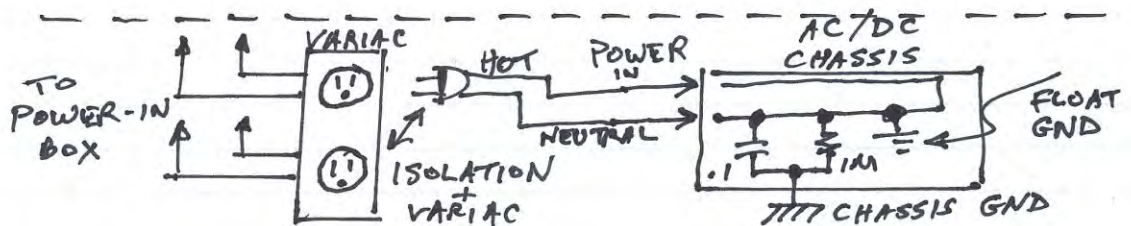
THE POWER-UP BOX

The diagram for the basic Power Up Box in the figure on page 13 shows the power going first to the Variac and

1. MEASURE 120VAC (RECEPTACLE - HOT - NEUTRAL)
2. MEASURE 2 VAC OR LESS FROM NEUTRAL TO GND (IF MORE REWIRE RECEPTACLE)
3. MEASURE ALL CONNECTED INSTRUMENTS (GND TO GND) = 0
4. PLUG AC-DC RADIOS INTO ISO ^{VAR} SOCKET WITH HOT - HOT
5. TURN ON RADIO POWER WITH ¹⁵⁰ VARIAC AT LOW SETTING SLOWLY ADVANCE VARIAC - ENSURE NO LARGE CURRENT AND ALSO ALLOW ELECTROLYTICS CAPS TO REFORM
6. PLUG TRANSFORMER TYPE RADIO INTO VARIAC SOCKET, PAYING ATTENTION TO POWER RATS.
7. BEFORE POWER - PULL TUBES OUT OF SOCKETS, THEN SLOWLY ADVANCE VARIAC TO ENSURE NO LARGE CURRENT DRAW OR TRANSFORMER HEATING
8. PLUG TUBES INTO SOCKETS AND ADVANCE VARIAC SLOWLY TO CHECK FOR CIRCUIT SHORTS AND ALLOW CAPACITOR REFORMING.

The Power on Box Procedure in the lower half of the figure on page 13 takes you step by step through testing both AC/DC radios and transformer powered types. The advantage of having the AC ammeter in the power up box is that it allows you to read the exact amount of current your radio is using when powered on and that should correspond to the radio's VA rating. If it is more, this tells you that your radio is shorted or that some power driven circuits are leaky or drawing more current than they should. This could happen with leaky capacitors, tubes or transformers.

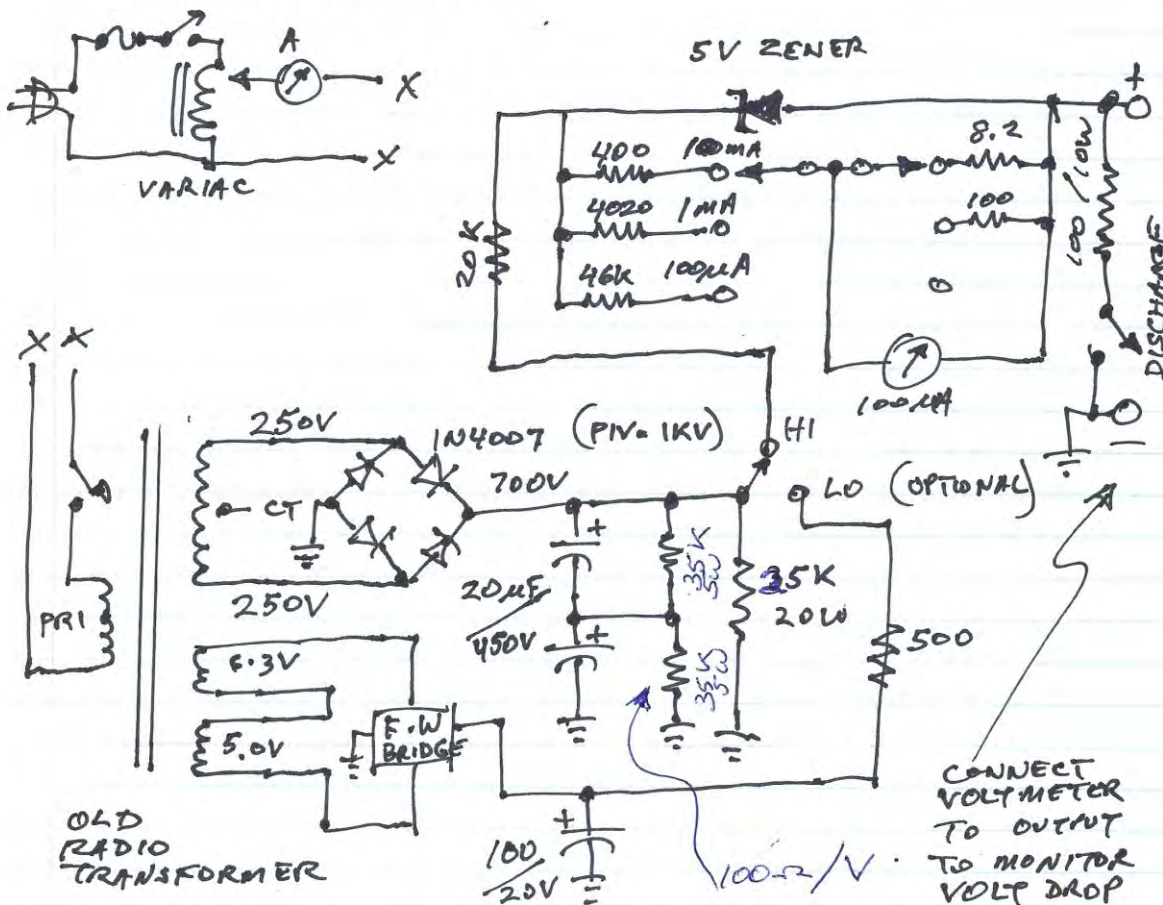
ORIG. POWER UP BOX

If you get really ambitious, you might want to build the add-on circuits shown in the figure on page 14. This circuit includes a salvaged radio transformer to allow up to 700 Volts to be used as a capacitor leakage tester and an electrolytic capacitor restorer. Why is this add-on so useful? Because testing capacitors properly takes more than just a simple capacitance meter. The photo, below, shows various cap testers starting with the old Heathkit Model IT-28 (upper left) that tested caps with a bridge type circuit, but also allowed leakage tests adjustable up to 600 Volts. These are very hard to find now. A Sencor Model LC102 (top right) full function tester provides many capacitor tests, including precise values and full leakage testing, but is high priced at \$1,500 dependent on where you buy it. Lower right is a low priced handheld capacitor tester with no leakage testing and finally, there is a MK-168 component tester (lower left), that probably offers the best 'bang for the buck'.

You can obtain an inexpensive MK-168 component tester from eBay for about \$30, which is perfectly good for most capacitor tests, but only the most expensive capacitor testers will also provide leakage testing. Ordinary capacitor testers use a microprocessor to charge a capacitor up by time and translate the reading into microfarads, but if the capacitor is leaky the reading could show too high. Besides, a capacitor could work at a lower voltage and still break down (fail) under higher operating voltages. This add-on tester allows you to test the capacitor at the rated voltage it is supposed to operate at. Usual expected values are indicated for various capacitors on the right lower side of the figure on page 14.

The voltage varying aspect of the Variac in the power on box allows for the capacitor operating voltage to be varied right up to its maximum required rating. The output of the transformer is a rectified DC voltage and the leakage reading is read off a 100uA DC meter with a set of range selected resistors. A

This same circuit can be used for reforming old leaky electrolytic capacitors using the directions on the lower right side of the figure on page 14. This being said, some experienced radio restorers say that reforming caps is usually a waste of time, but you can experiment for yourself and form your own opinion.

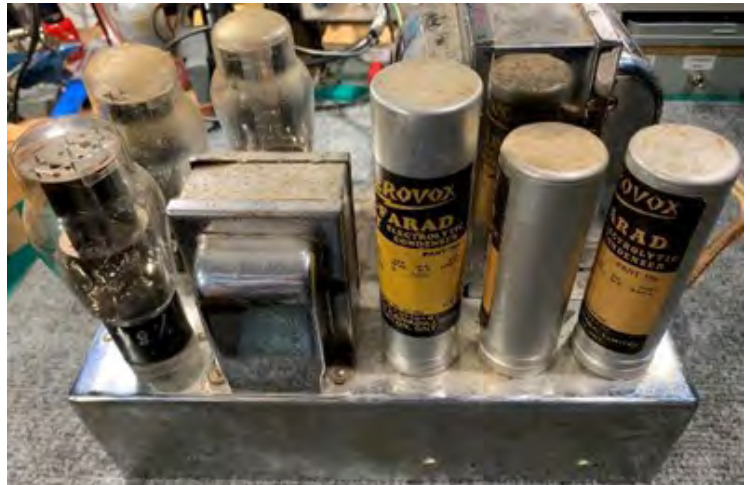
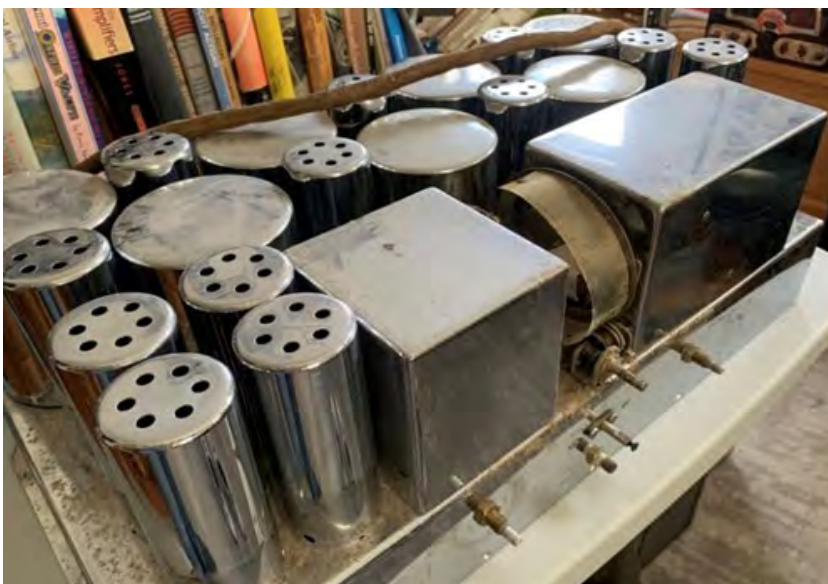
Power supply/power amplifier: the large chrome-plated power transformer and choke dominate the upper side of the power supply/power amplifier chassis (photo, right of chassis on arrival), and a large rectangular audio driver transformer on the underside. The line cord and a 'flying lead' for the on-off switch enter through a grommet on one end of the chassis, and there is a 110/120vAC switch, a keyed 6 pin 'Jones' ('Cinch') style socket that provides power to the tuner chassis, and a 6 pin speaker socket on the other end.

Tuner chassis: most coils, chokes and transformers on the tuner chassis are enclosed in large chrome-plated cans, these being push-on (friction-fit) over the lip of the can bases, which are fixed to the chassis (photo, below of chassis on arrival). The shortwave antenna coil and tuning gang are enclosed in rectan-

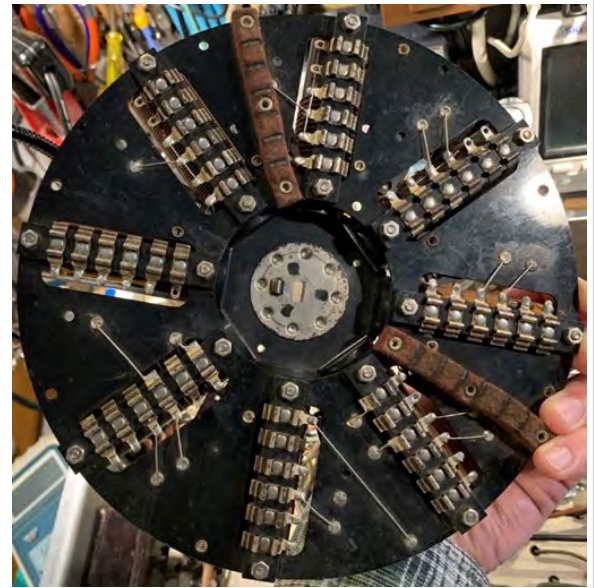
gear mounted on a horizontal shaft that engages with a second bevel gear, mounted on a vertical shaft, that rotates the carousel. Detents located in a metal insert at the centre of the carousel, visible in the photo, right, engage with spring-loaded pins mounted in a pot metal casting housing the bevel gears, to stop and hold the carousel at each of the four band change positions. Two end stops are cast into the section of the pot metal that prevent over-rotation of the carousel (see discussion on this in the tuner refurbishment section of this article). The use of sealed 'bathtub' style paper capacitors is interesting for a 1934 domestic radio – these look like high quality parts similar to those used in military and communications sets of the mid-late thirties onwards, these usually having a paper-in-oil dielectric (I suspect in this case the dielectric to be plain paper dielectric capacitors sealed in tar. The parts list notes that three of these cans, located on the rear apron of the tuner chassis, contain a 'choke and condenser assembly'.

The coil carousel was removed (photo, left) to facilitate closer inspection and component replacement work. This revealed that the housing for the

bevel gears was made from chrome-plated pot metal that had started to fail due to '[pot metal cancer](#)', with one piece chipped off and several minor cracks developing through the casting. This is a known issue with pot metal, and I have encountered many bad cases of pot metal decay in other sets of the 1920's through the 1930's. However, this casting still had good structural integrity and did not show any signs of swelling or warping, which often happens.

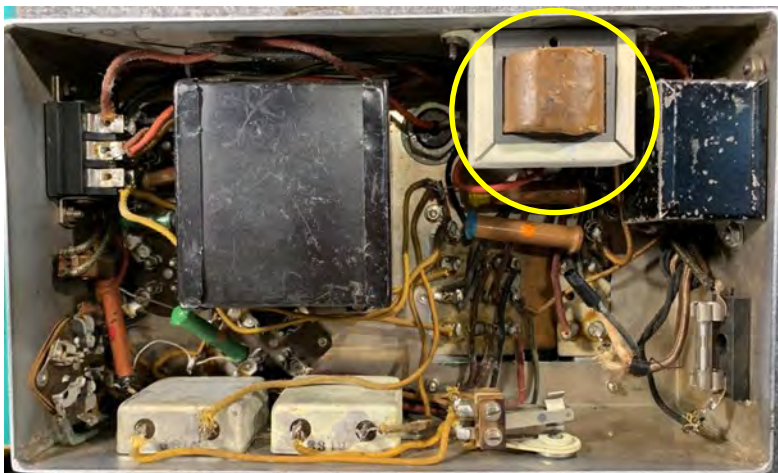
Further inspection of the power supply/power amplifier chassis confirmed that it had several modifications and faults:

- There was a (non-original) Canadian-manufactured 'Hammond' centre-tapped choke (circled yellow in the photo, left), which I suspect is actually a push-pull output transformer with the connections to the secondary winding cut away, the stubs of which could be observed when the unit is examined closely, mounted under the chassis associated with some wiring mods that, after tracing out, had been undertaken to replace the interstage (driver) transformer wired between the push-pull #56 audio driver tubes on the tuner chassis and the 2A3 power

output tubes on the power supply/power amplifier chassis. The primary of the original interstage transformer likely failed (open circuit) due to a short or an 'old age' failure, such as corrosion of the windings. This transformer was still present under the chassis, albeit with its primary windings cut away, but with its secondary windings still connected to the 2A3 audio output tube grids. The centre-tapped Hammond choke had been wired into the circuit to provide plate voltage to the two #56 audio driver tubes in the tuner chassis (in place of the driver transformer primary winding), and the grids of the 2A3 tubes connected to the #56 plate circuits via the two 0.5uF coupling capacitors that are part of the phone jack circuit;

- Re-wind the original transformer: not feasible unless the original specs were known;
- Find an exact Scott AW15 replacement part, eg. from an AW15 'parts set';
- Leave the arrangement as-is and evaluate the circuit once operational; and/or
- Find a suitable (non-Scott) replacement driver transformer and revert the circuit as per the schematic.

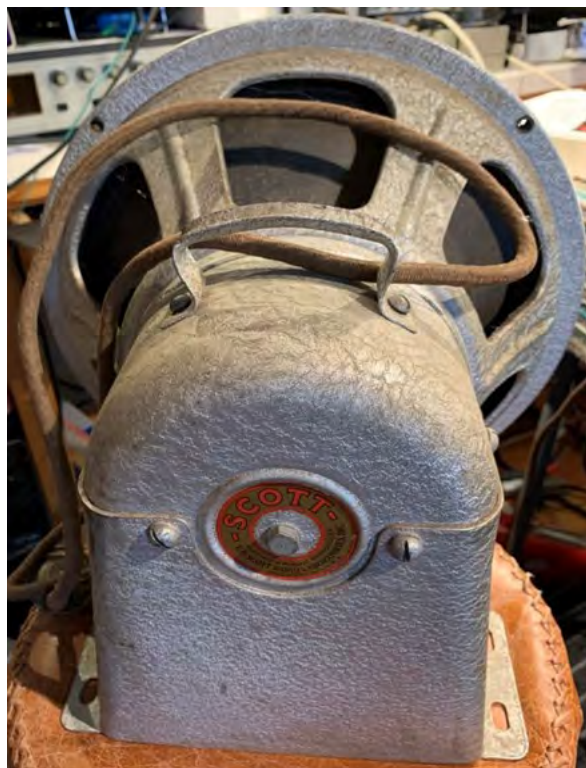
With the power supply–amplifier chassis on the bench, I thought it would be a good opportunity to plug in the speaker (photo, right) and test the field coil and audio output transformer. As noted above, the AW15 speaker has two field coils: one in the plate circuit feeding high voltage to the tuner chassis and one in the cathode circuit of the 2A3 output tubes. The cathode circuit field coil tested ok, with a DC resistance of 750ohms, as per the schematic, but the plate supply field coil was open–circuit – it should measure 2175ohms. With this field coil open circuit, no plate voltage would be supplied to the tuner chassis, so the tuner would be inoperative, and the speaker electromagnet would not be fully–functional, ie. the magnetic field would be weaker than designed, reducing the efficiency of the unit.

- have the speaker field coil repaired. This would entail complete disassembly of the speaker and re-winding the field coil;

- buy another AW15 speaker in working condition (if one could be located); or

- replace the field coil with a resistor and/or choke to simulate the power supply purpose of the field coil and thus allow the correct plate voltage to be fed to the tuner chassis, hoping that the remaining good field coil, ie. the one in the cathode circuit of the 2A3 tubes, was sufficient to magnetize the speaker such that it produced adequate volume/audio quality.

I recommended the last option to the set's owner as a starting point, and this approach was accepted by the owner as being appropriate.

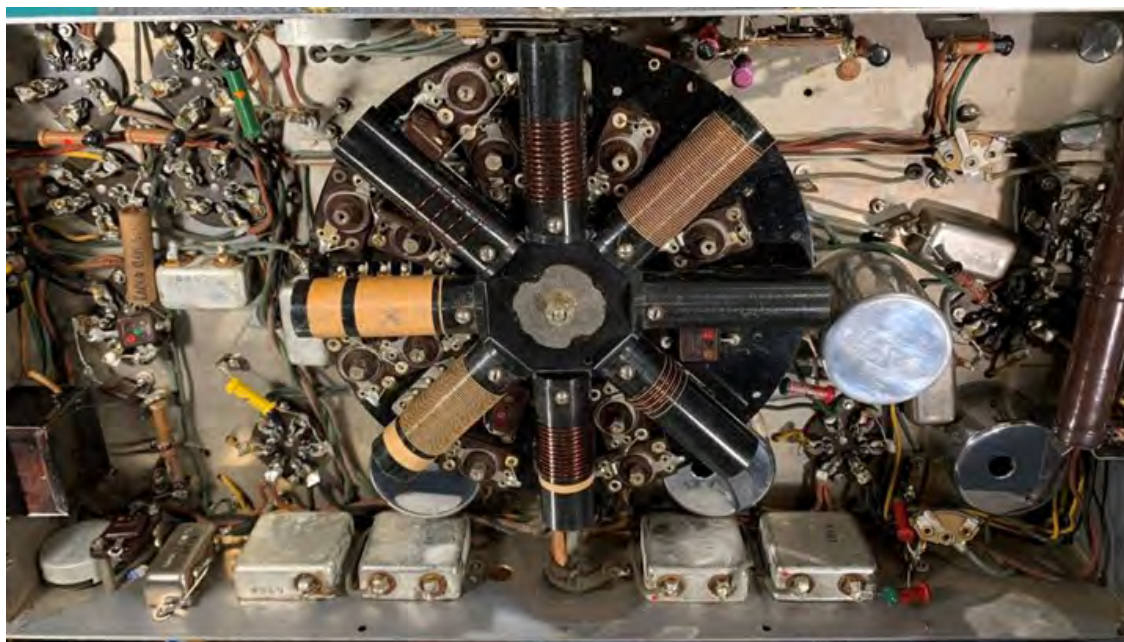
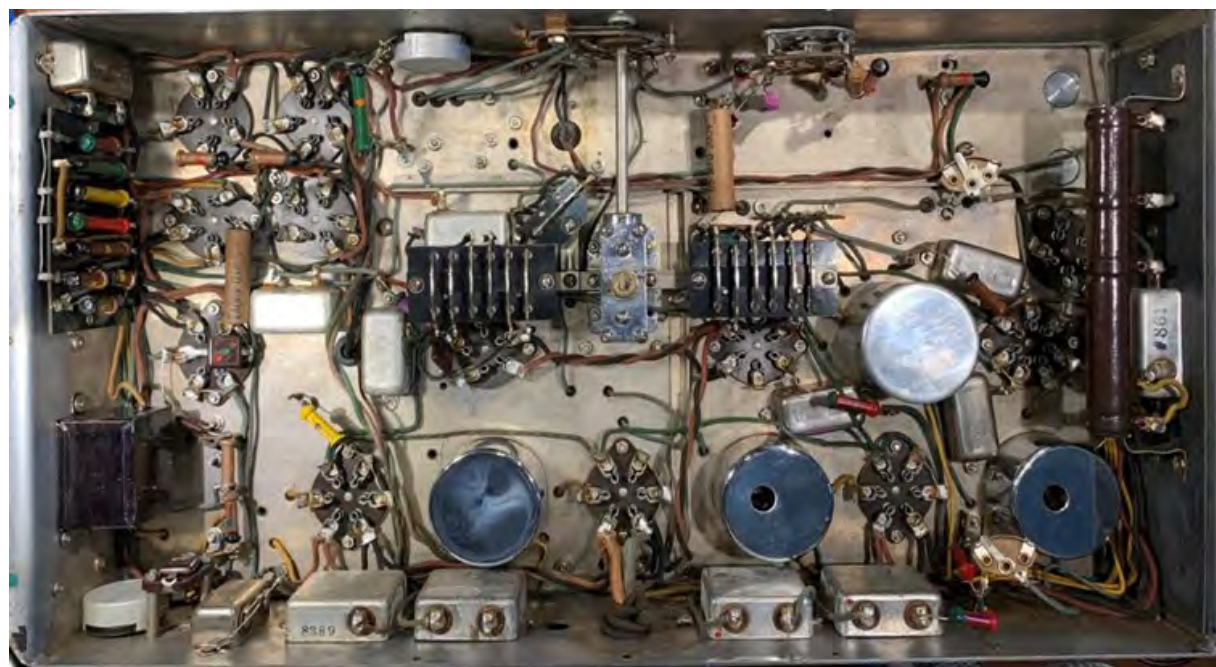
A closer look at the underside of the tuner chassis (photo, right) revealed that in addition to the circuit differences noted above, there was a large number of differences in the layout in this example compared with either of the two chassis layout drawings I had found for the set. For example, this chassis has several capacitors and resistors in different locations than shown on the layout diagrams, the '215v HT Filter' had been omitted, and two

above-chassis electrolytics were absent, with blanking caps present in the holes in the chassis the electrolytic capacitors would have occupied.

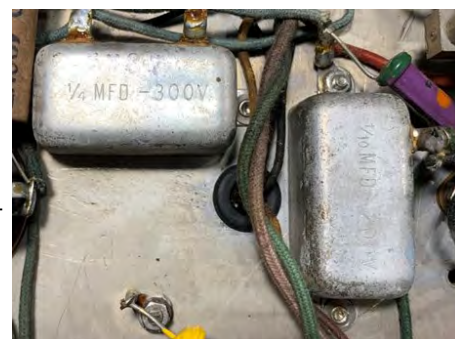
Given that the set is a 'Scott', and is therefore a collector's item, I suggested that a compromise be reached for the under-chassis work in that the original 'bathtub' capacitors (examples shown in the photo, right) be left in place and the new parts installed in such a manner as to allow further work on the chassis to be undertaken in the future should a subsequent owner wish to expend the time and effort needed to render the under-chassis appearance 'factory fresh'. For any replacement resistors and for tubular paper capacitors, these would be removed and retained with the chassis so the capacitors could be restuffed and reproduction resistor bodies fabricated. This suggestion was agreed to by the owner and this was therefore the refurbishment approach adopted for this AW15 tuner chassis.
